PHOTOGRAPHIC INTERPRETATION REPORT

TCS-80248/65

# HSIANG-HSIANG EXPLOSIVES COMPLEX CHINA

February 1965

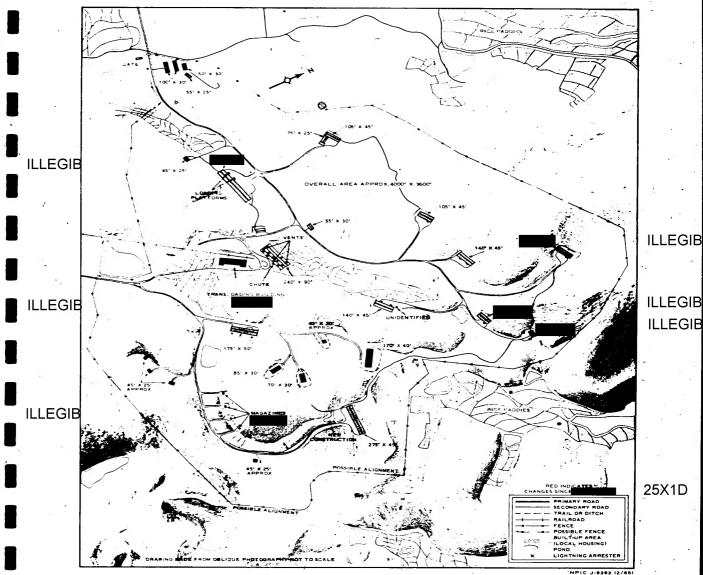
FIGURE 5. LOADING AND STORAGE AREA.

The storage capacity of the Loading and Storage Area, which is situated in hills northeast of the Processing Area, has been increased significantly since (Figure 5). There have not been any changes in the area security provisions.

A new transloading building measuring 180 by 45 feet was built near the southern entrance to the area, and a new rail spur was constructed to the building. Both the building and the rail

spur were added to the area between during the same period a new road was constructed around the transloading building.

Eight new explosives storage buildings of various sizes have been added to the area since. These buildings, which 25×10 dividually served by new roads, are located in small valleys; this terrain provides good blast protection. Five of the buildings were constructed between

between last 2 were probably still under construction but the small scale of the photography limits interpretation of details. The 3 larger buildings and the smaller building nearest to them are circled by narrow trails or ditches.

New construction began after photography of at a location in the eastern section of the area. This new construction consists of a rectangular scarred area and road construction. The road pattern indicates that additional storage buildings will probably be built in this area.
